Inspection/Test Report: Seats, their Anchorages and any Head Restraints Vehicles of Category M1

UNECE Regulation 17.09 to Supplement 1

Name and Address: Tripod Mobility B.V.
Collseweg 10
5674 TR Nuenen / The Netherlands
Type: SKT
Commercial Description: Caddy Tripod / Caddy Maxi Tripod
Category: M1 SPV (WAV)

Report Number: ESY534417 Issue: 1

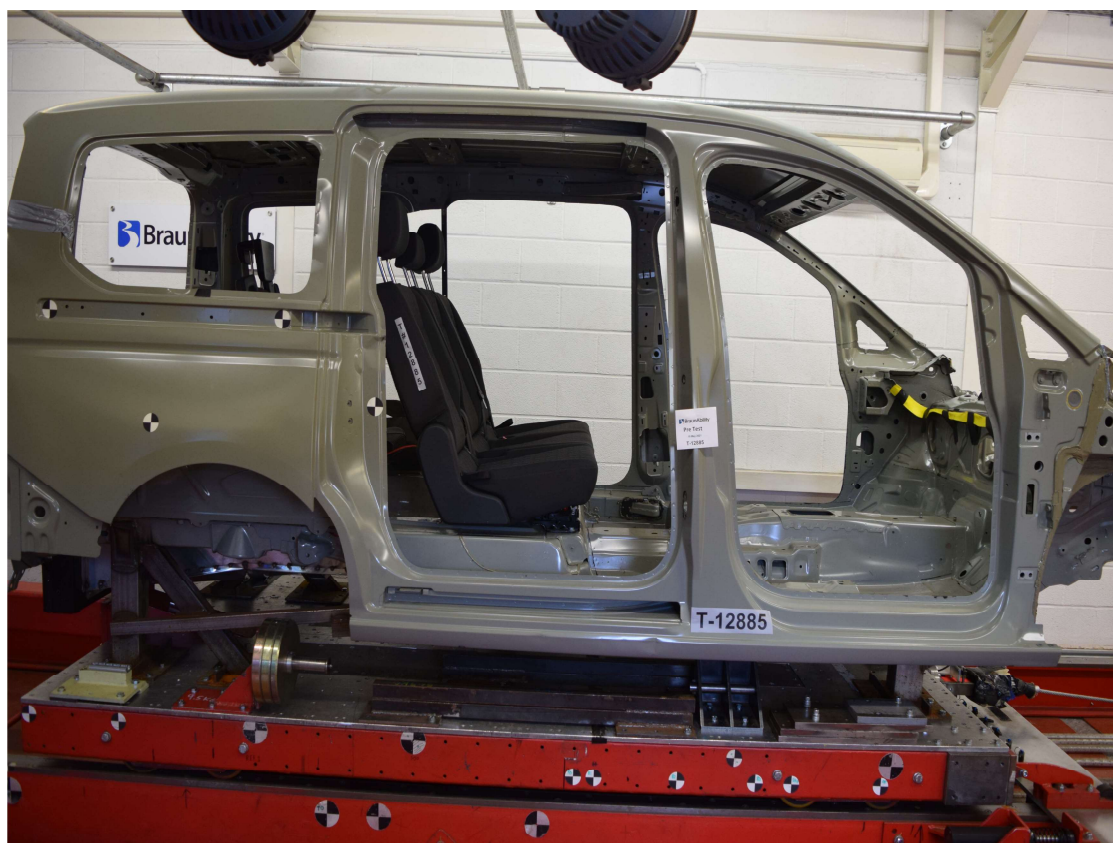
Pre Test

Test Objectives & Setup Details:
Tripod VW Caddy Max (Rearward) REG 17

Test Photos T-12885

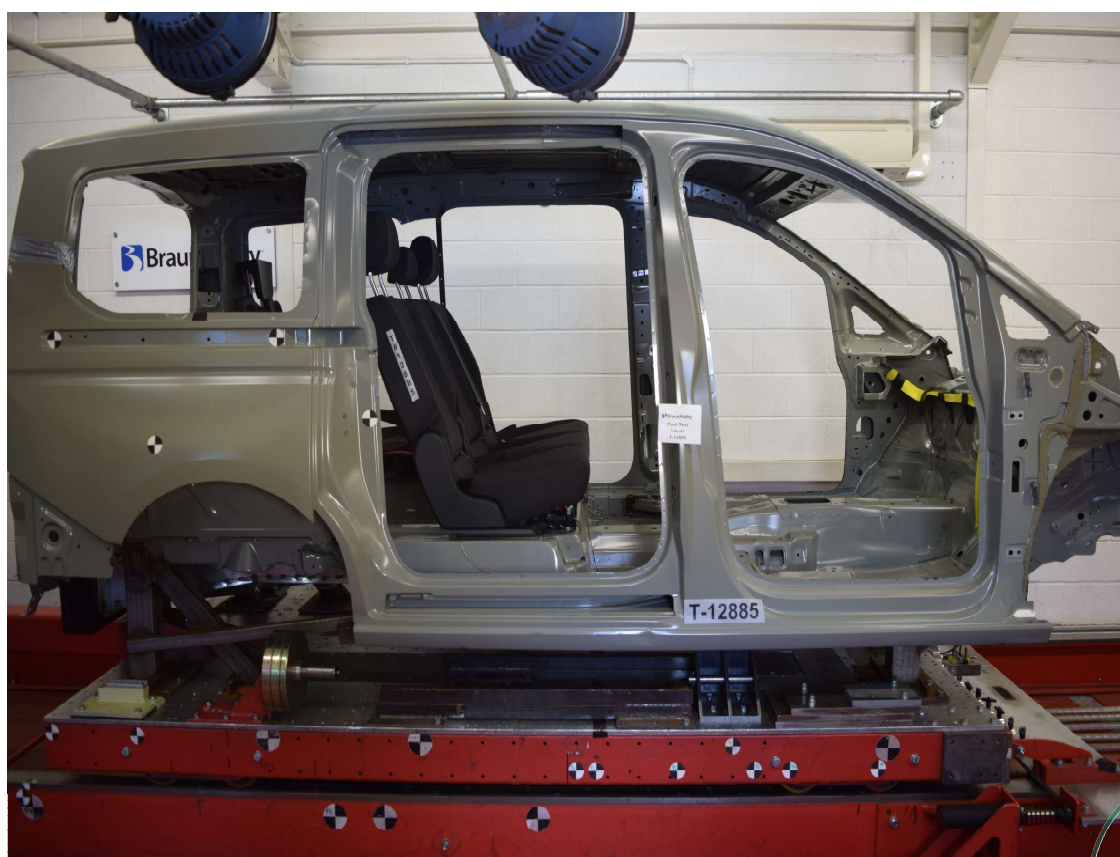
Post Test

All Held for over 30ms

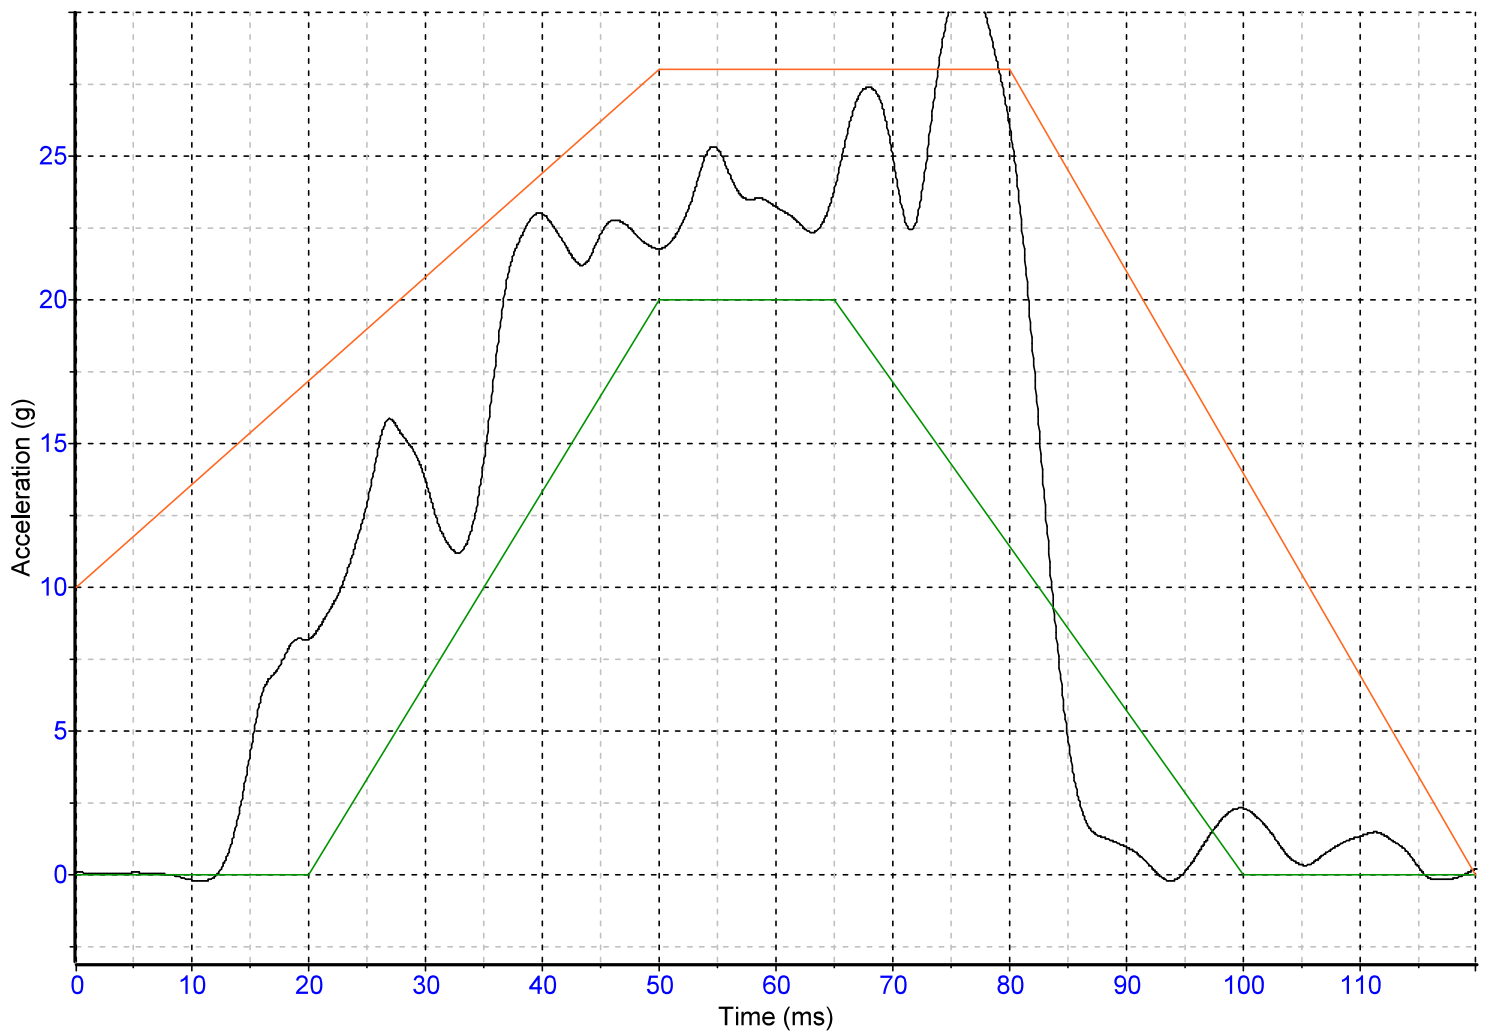
Pulse Graph for Deceleration to Reg 17 T-12885

Time at 20g (Single Peak) : 44.9 ms [t1 : 36.7 ms, t2 : 81.6 ms] (Cumulative) : 44.9 ms

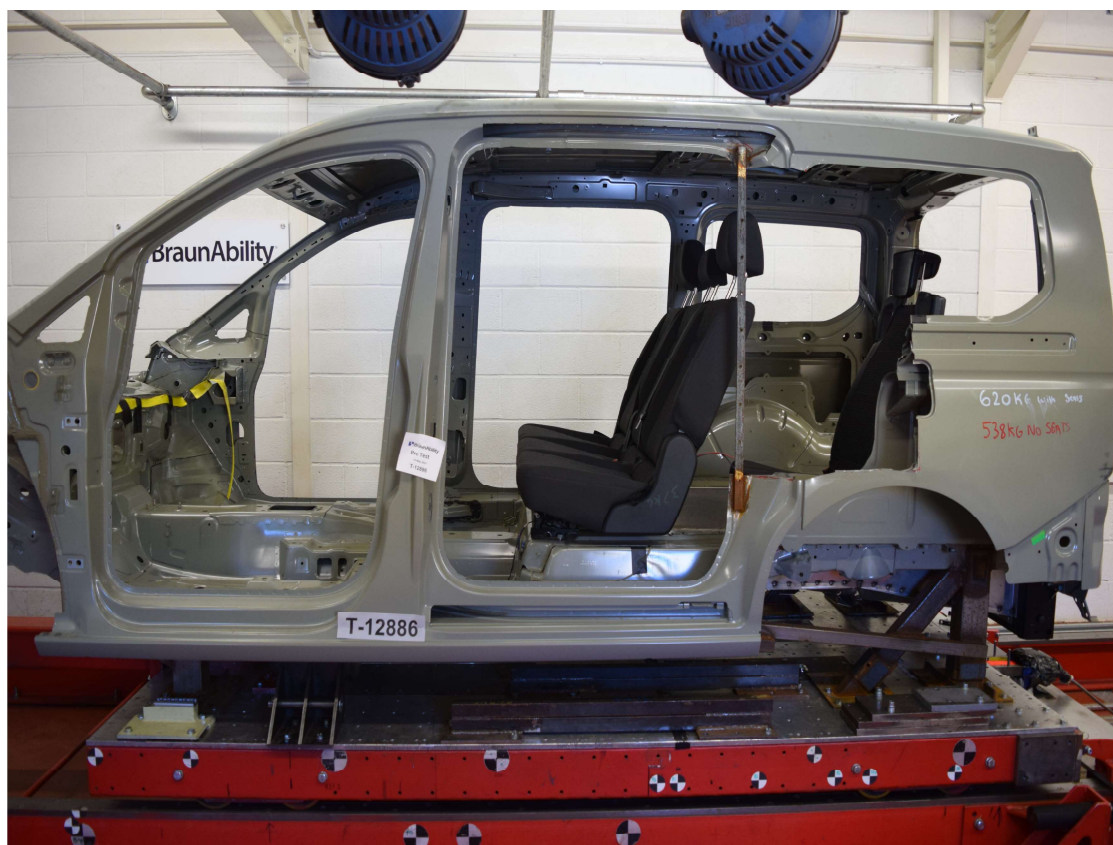
Pre Test

Tripod VW Caddy Max (Rearward) REG 17

Test Photos T-12886

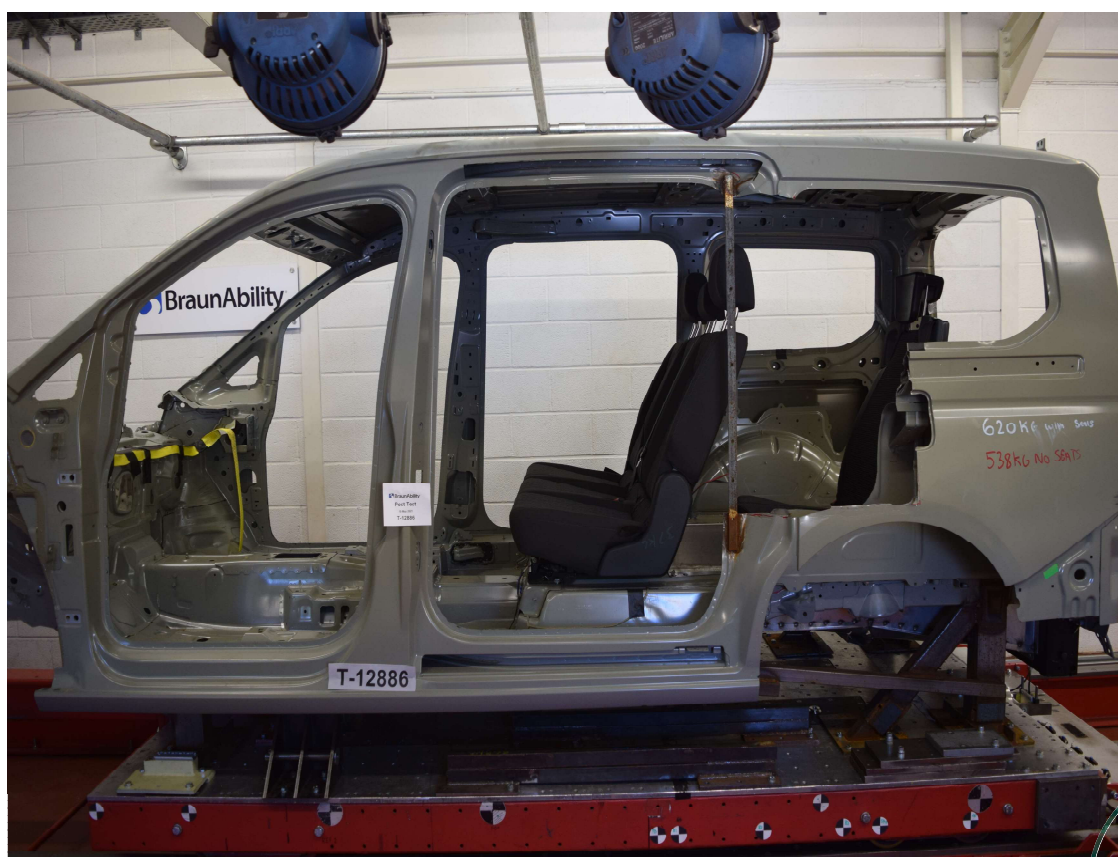
Post Test

All Held for over 30ms

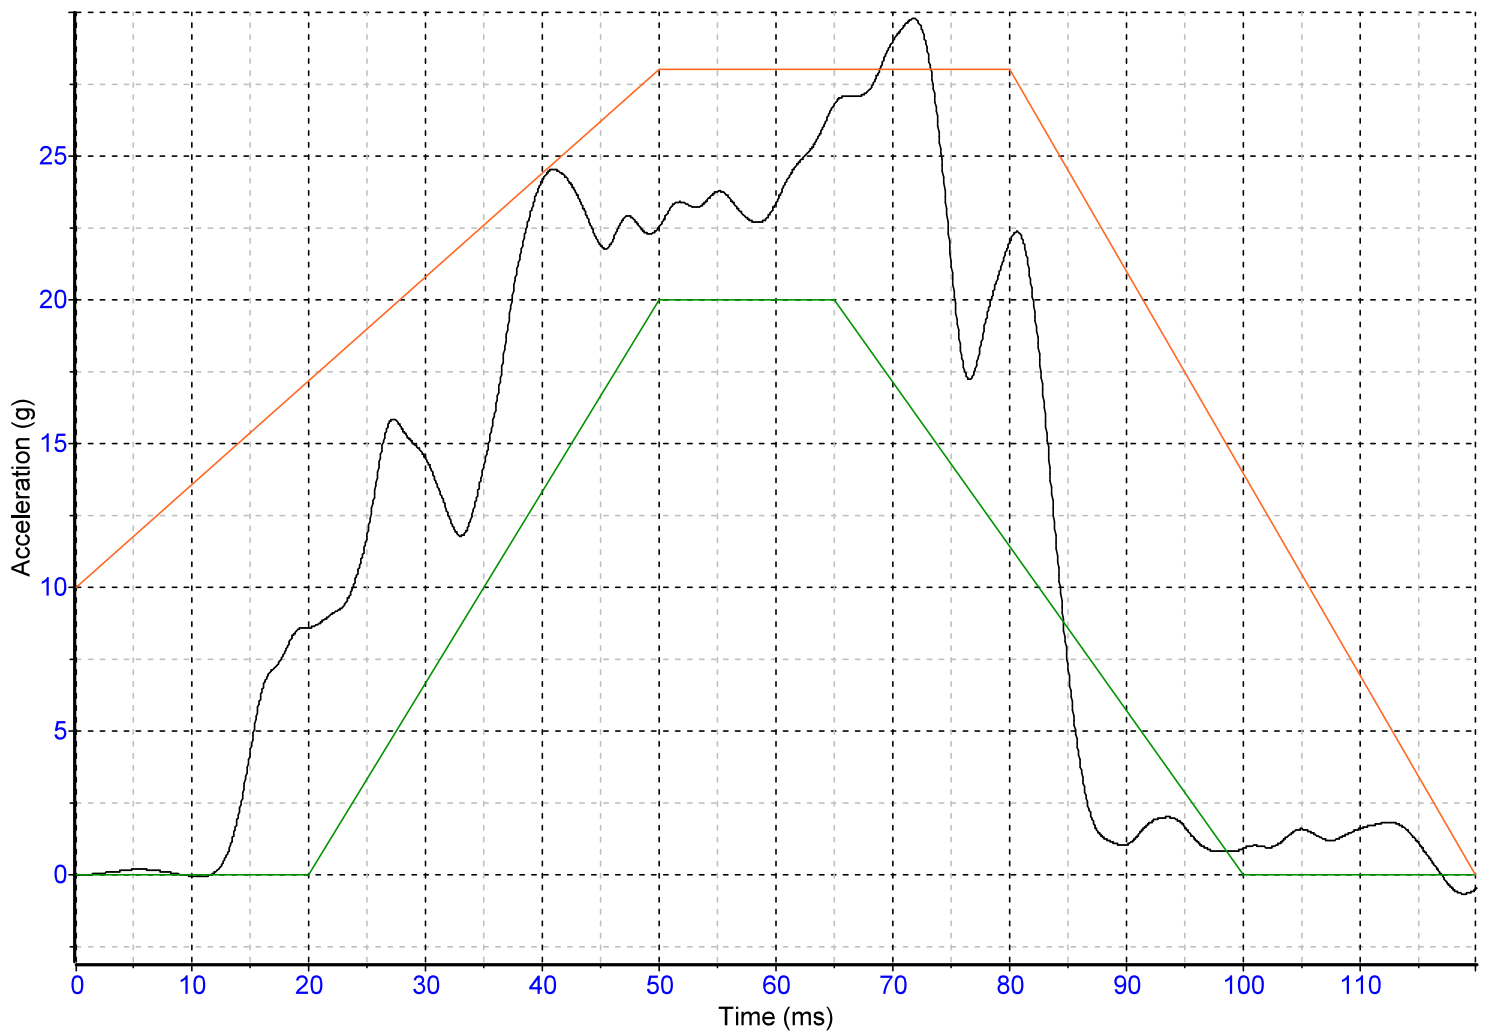
Pulse Graph for Deceleration to Reg 17 T-12886

Time at 20g (Single Peak) : 37.9 ms [t1 : 78.5 ms, t2 : 82.0 ms] (Cumulative) : 41.5 ms

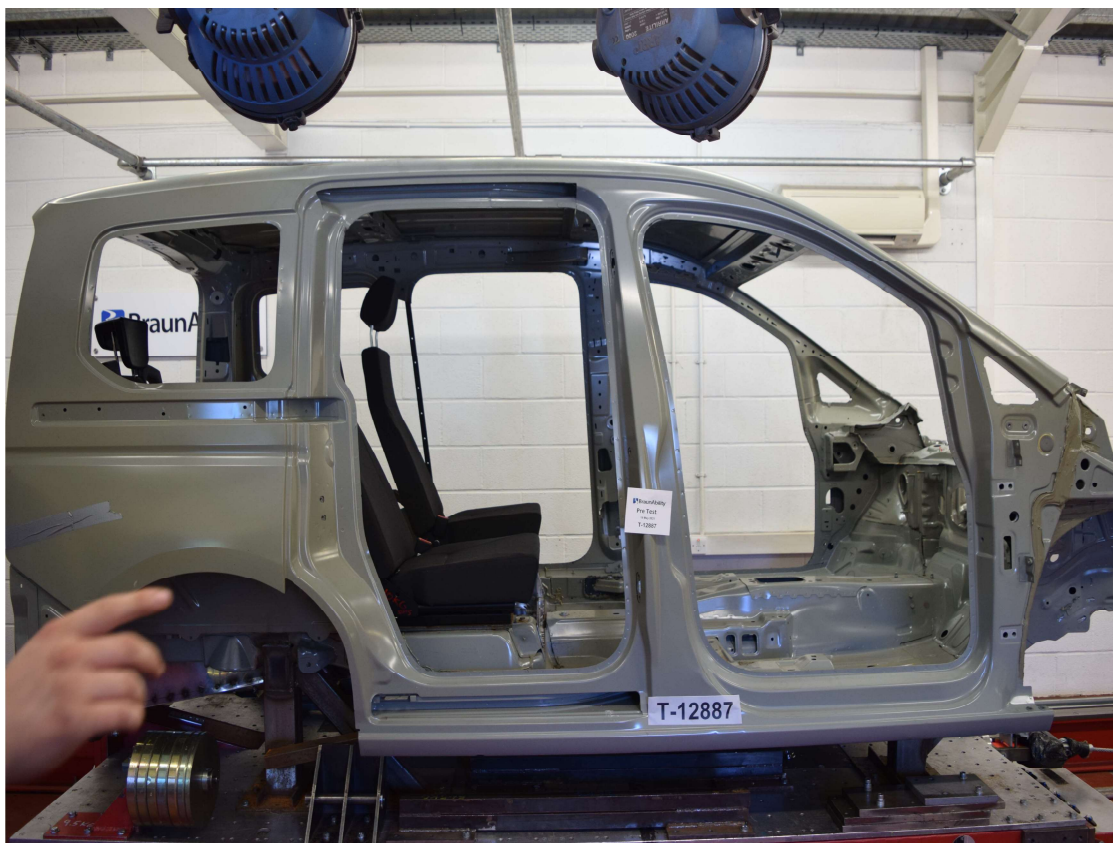
Pre Test

2 Tripod seats (TR04S) 2nd row + Triflex seats 3rd row. (Rearward) Caddy Short

Test Photos T-12887

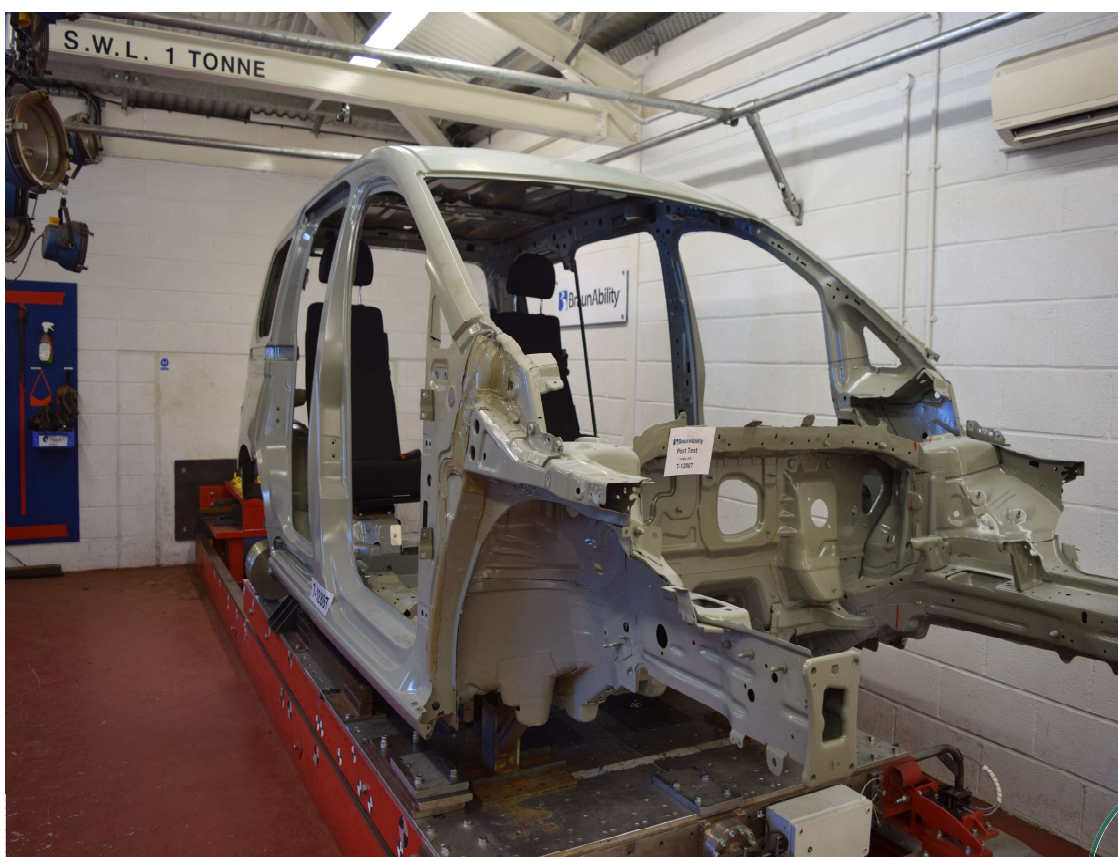
Post Test

5.2.5	No failure shall be shown in the seat frame or in the seat anchorage, the adjustment and displacement systems or their locking devices	Pass
5.2.6	No release of the locking systems shall occur during the test	Pass
5.2.7	After the tests, the displacement systems intended for permitting or facilitating the access of occupants shall be in working order; they shall be capable, at least once, of being unlocked and shall permit the displacement of the seat or the part of the seat for which they are intended	Pass

All Held to R17

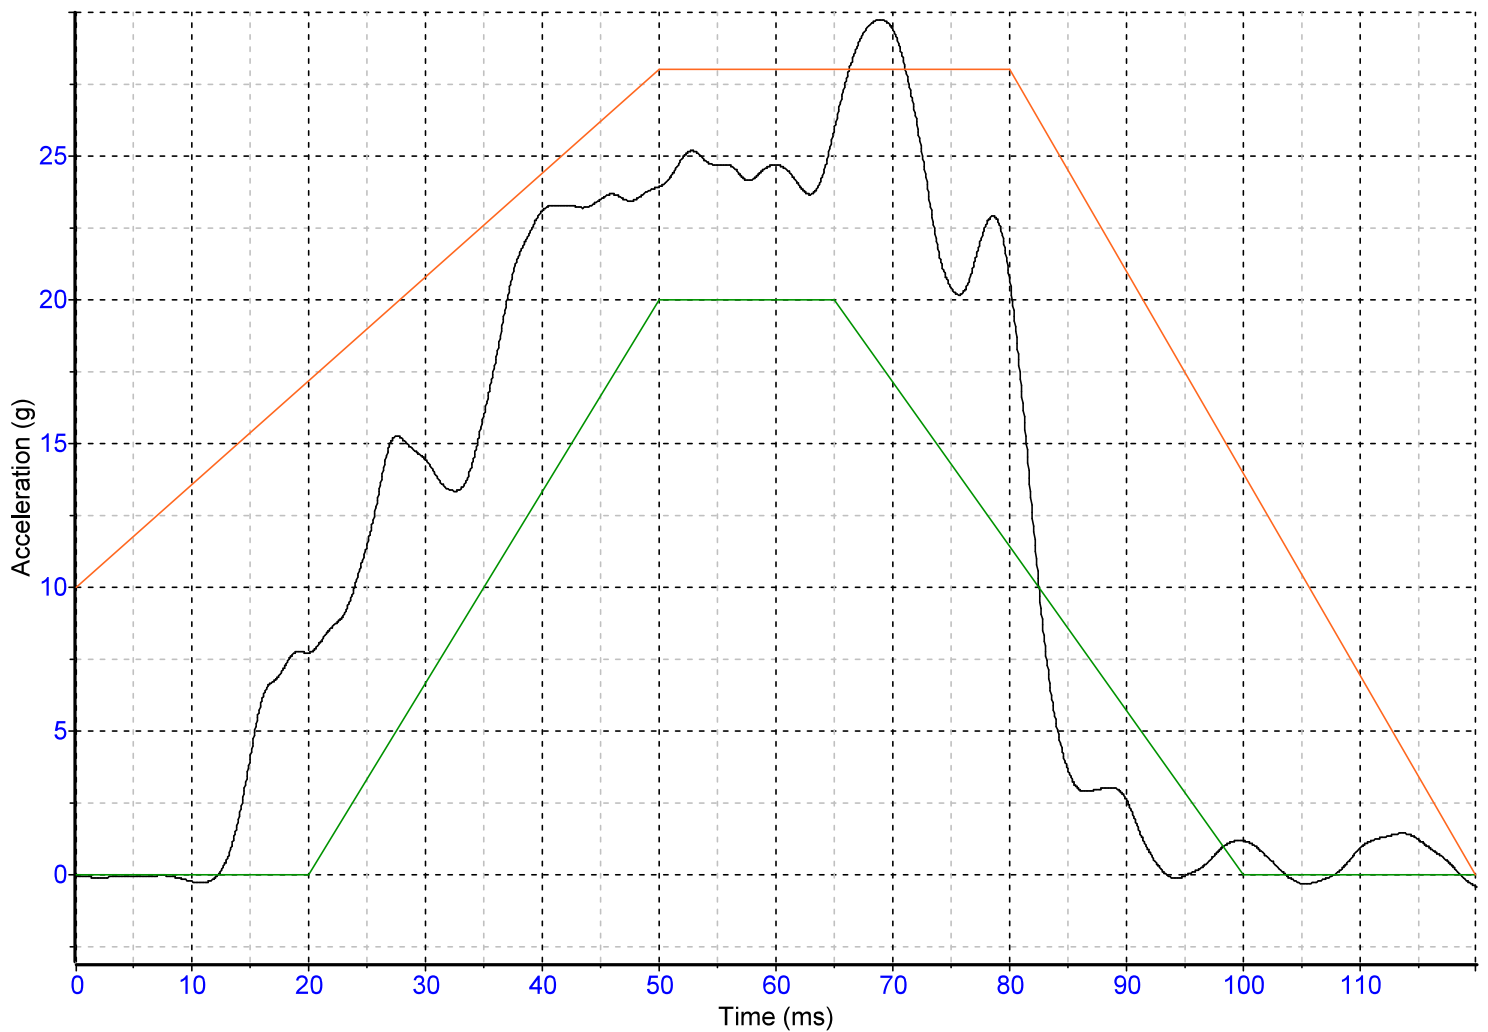
Pulse Graph for Deceleration to Reg 17 T-12887

Time at 20g (Single Peak) : 43.2 ms [t1 : 37.0 ms, t2 : 80.2 ms] (Cumulative) : 43.2 ms

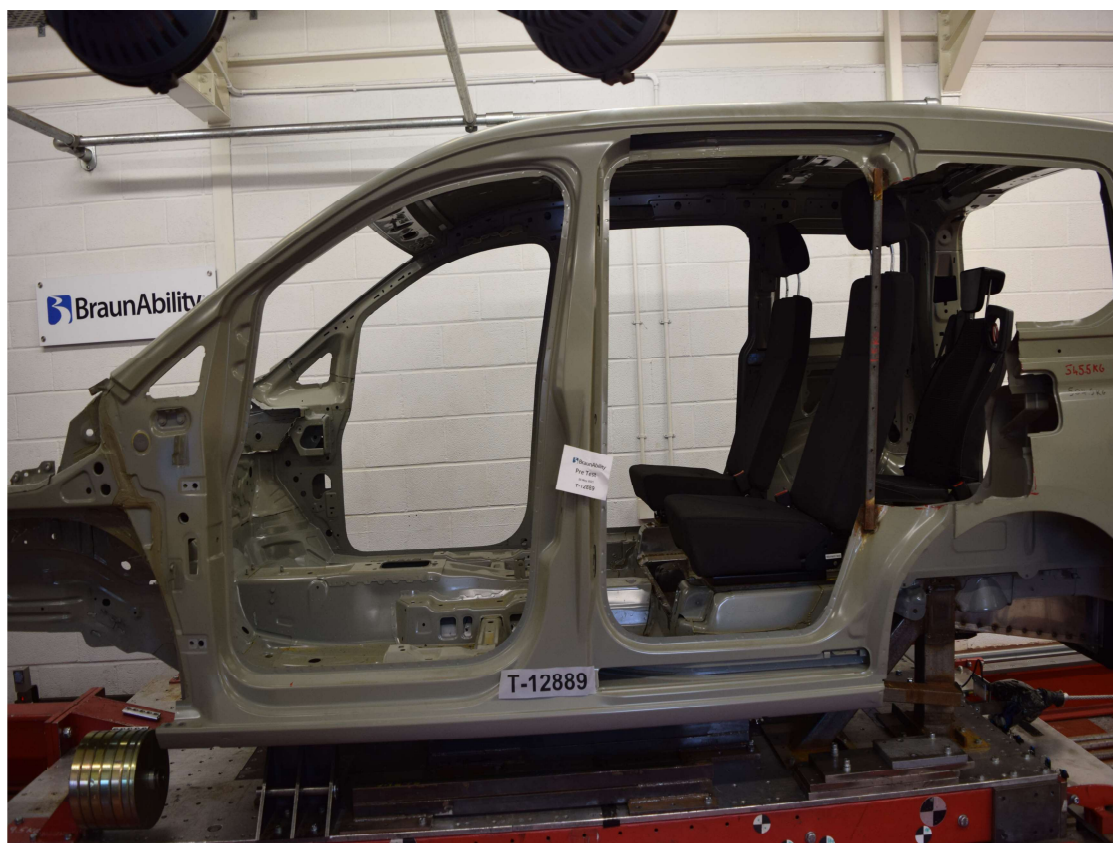
Pre Test

2 Tripod seats (TR04S) 2nd row + Triflex seats 3rd row. (Forward) Caddy Short

Test Photos T-12889

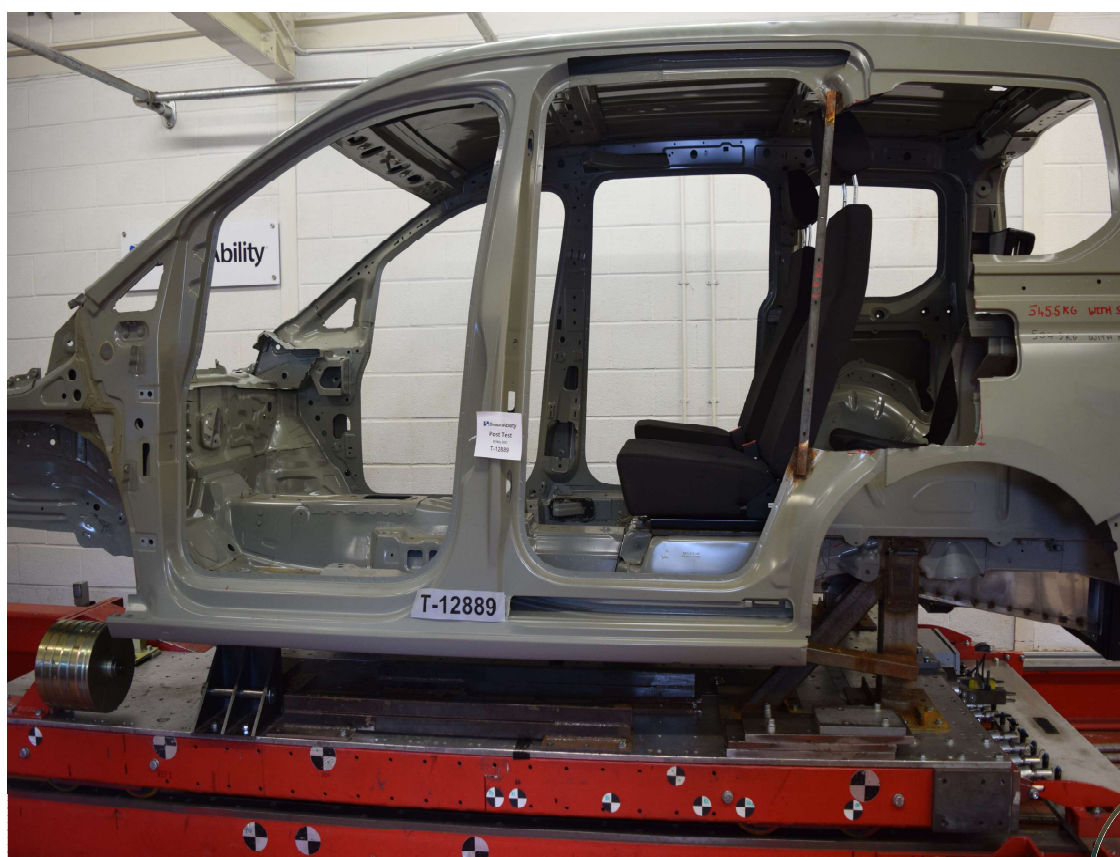
Post Test

5.2.5	No failure shall be shown in the seat frame or in the seat anchorage, the adjustment and displacement systems or their locking devices	Pass
5.2.6	No release of the locking systems shall occur during the test	Pass
5.2.7	After the tests, the displacement systems intended for permitting or facilitating the access of occupants shall be in working order; they shall be capable, at least once, of being unlocked and shall permit the displacement of the seat or the part of the seat for which they are intended	Pass

All Held as required for Reg 17

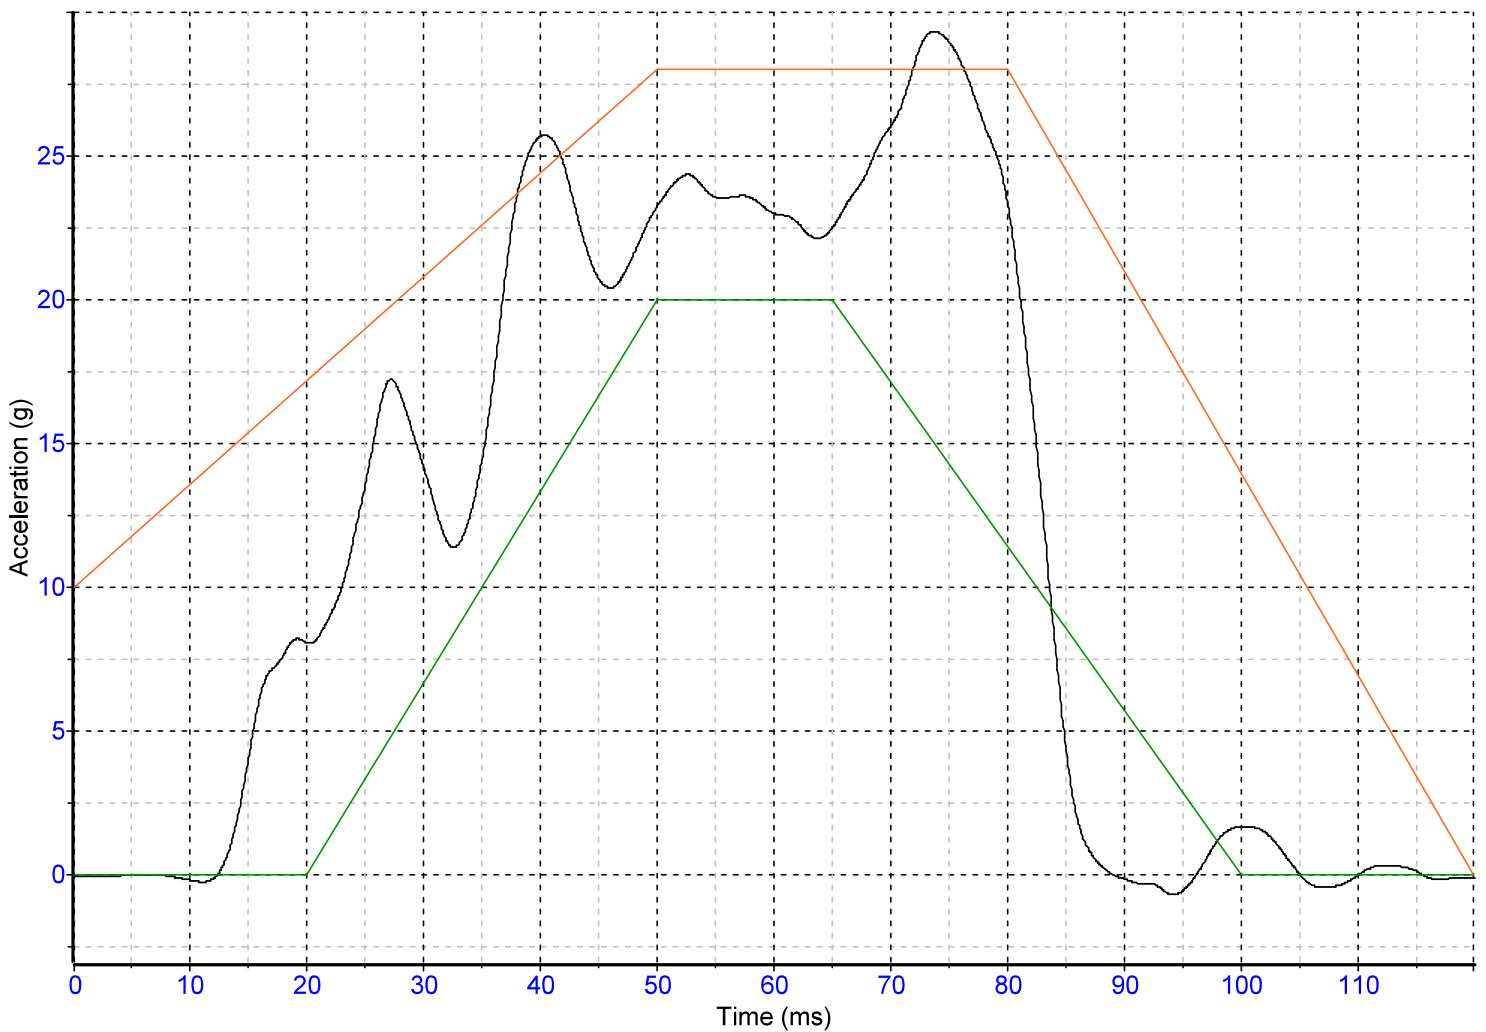
Pulse Graph for Deceleration to Reg 17 T-12889

Time at 20g (Single Peak) : 44.3 ms [t1 : 36.8 ms, t2 : 81.1 ms] (Cumulative) : 44.3 ms
